GE APPLIANCES
a Haier company

Service Bulletin

HL04-18

Intermittently Spin Up, Wet Loads, Not Spinning

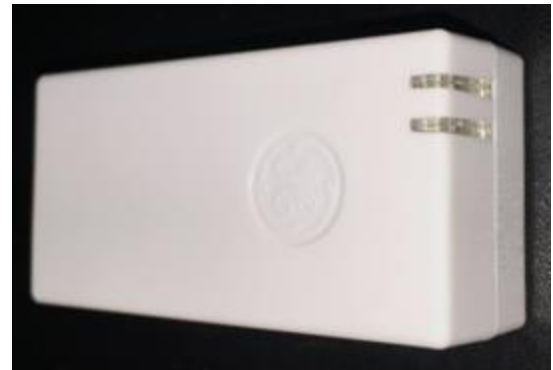
Upon entering fault code test 1 in service mode, technicians will find out of balance fault 26 has been set. Washers will spin normally in service mode test 14, but will not spin outside of service mode.

Factory Service Technicians – Use NewFI to update washer software with latest version.

Customer Care Technicians – Order Software Update Module (SUM) **WH98R23015001**.

This update fixes a falsely detected out of balance condition.
